Chena River Lakes Project  
Fairbanks, Alaska

*Overview of Tanana River monitoring and  
research studies near Fairbanks, Alaska*

OVERVIEW OF TANANA RIVER MONITORING AND  
RESEARCH STUDIES NEAR FAIRBANKS, ALASKA  
(with Appendices)

Prepared by  
U.S. Army Cold Regions Research and Engineering Laboratory  
Hanover, New Hampshire

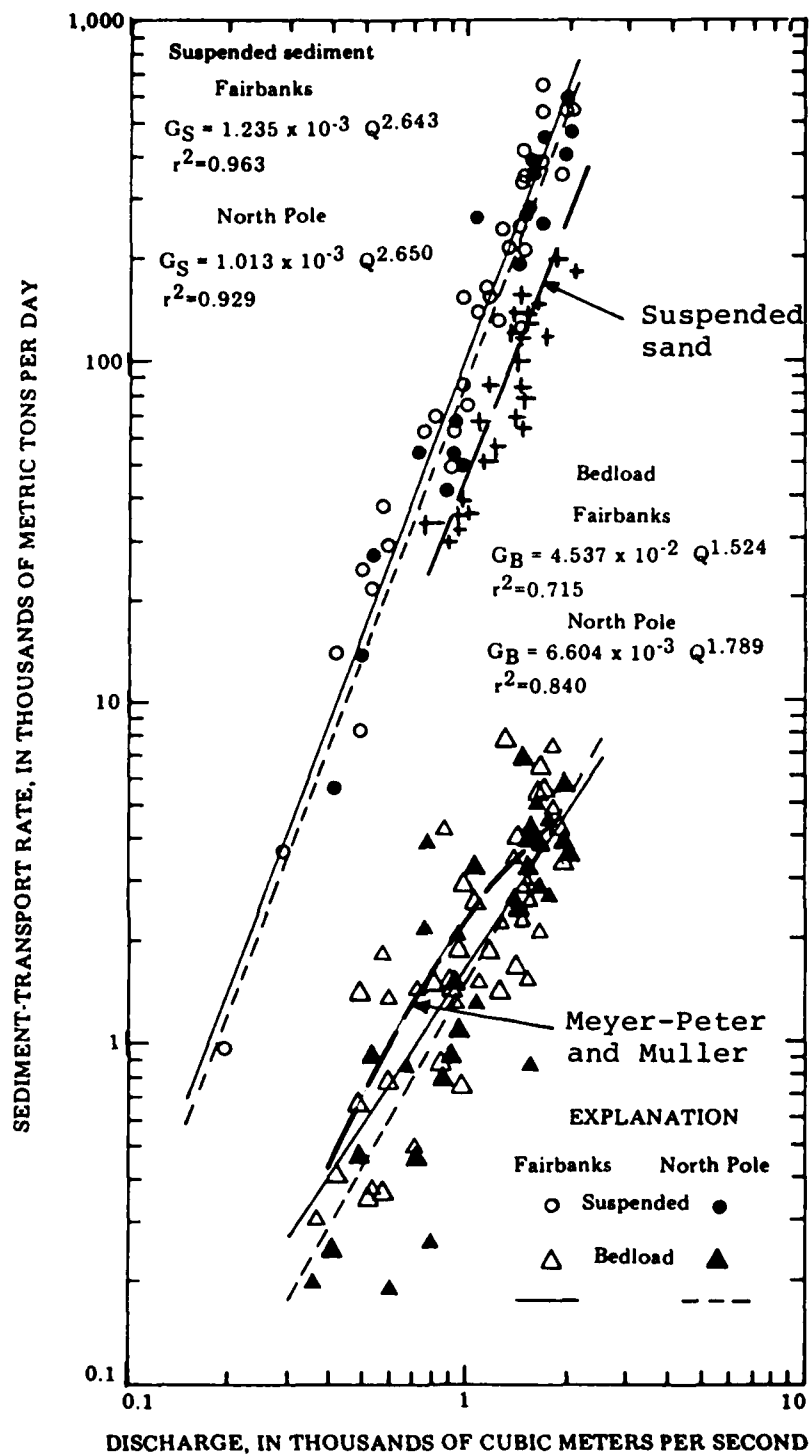
FIGURE 4.5 Sediment-transport rate as a function of discharge, Tanana River at Fairbanks and near North Pole, 1977-81.

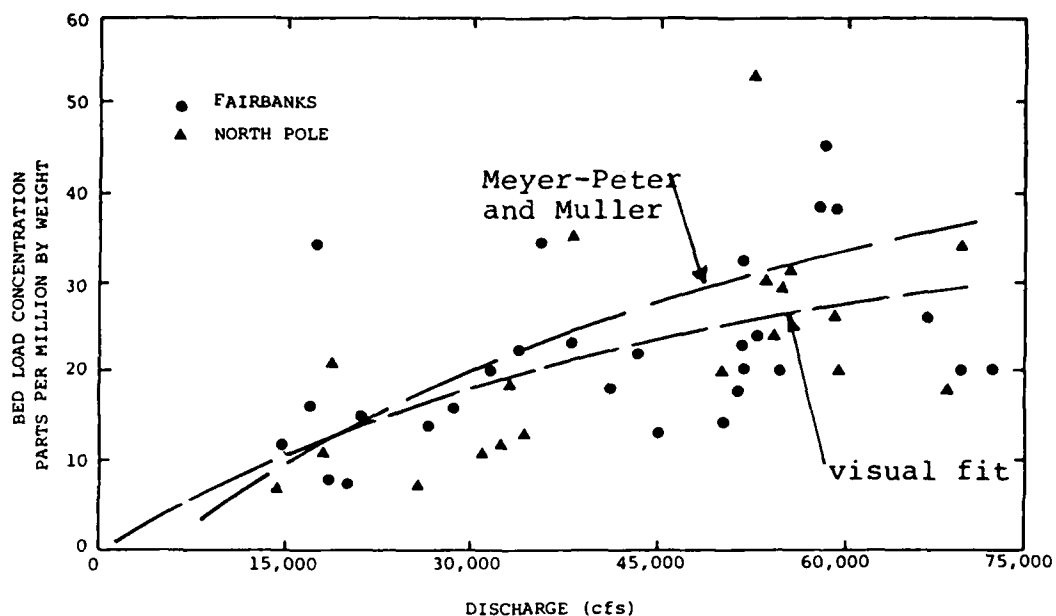
Figure 4.6. Bed-load 'concentration' vs discharge.

Table 4.9, on the basis of Figure 4.6 and Table 3.1, computes estimated bed load by months in an average year. The estimated total of 335,000 tons is comparable with the reported average of 358,000 tons for 1977-81 (Table 4.8). Month-by-month distributions of estimated bed load and water flow are illustrated in Figure 4.7; it should be noted that estimates for winter months are inferred only on the basis of open-water data, and may be inaccurate.

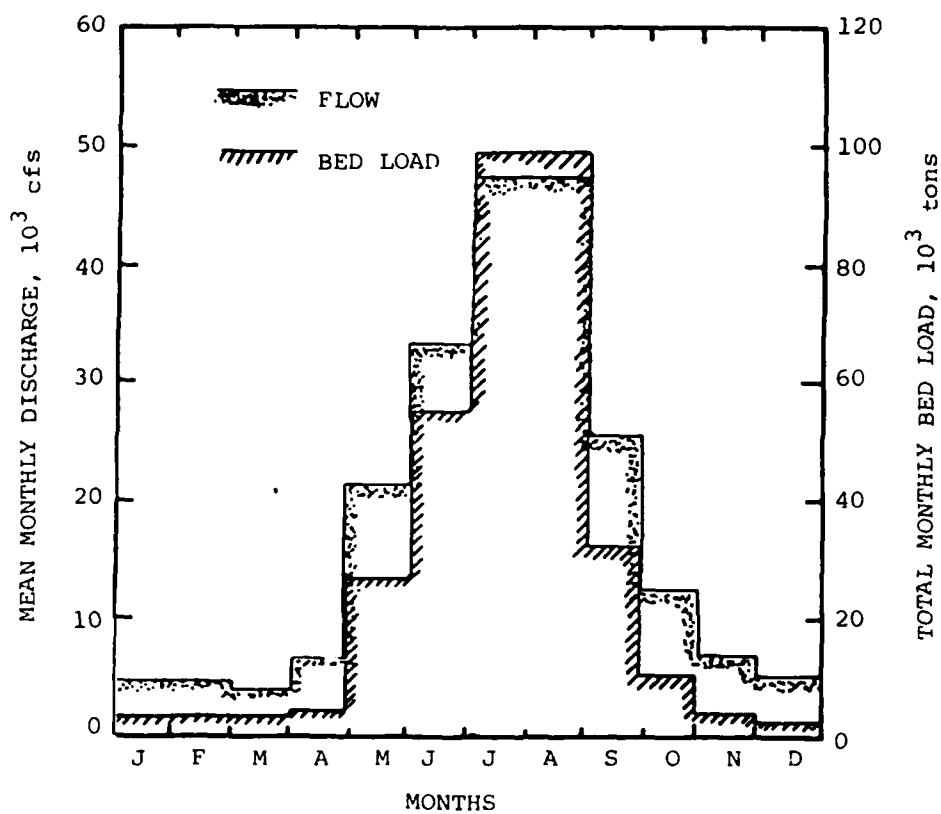
Figure 4.7. Average month-by-month distributions of flow and bed load. (Note: Bed-load distributions are derived using Figure 4.6.)

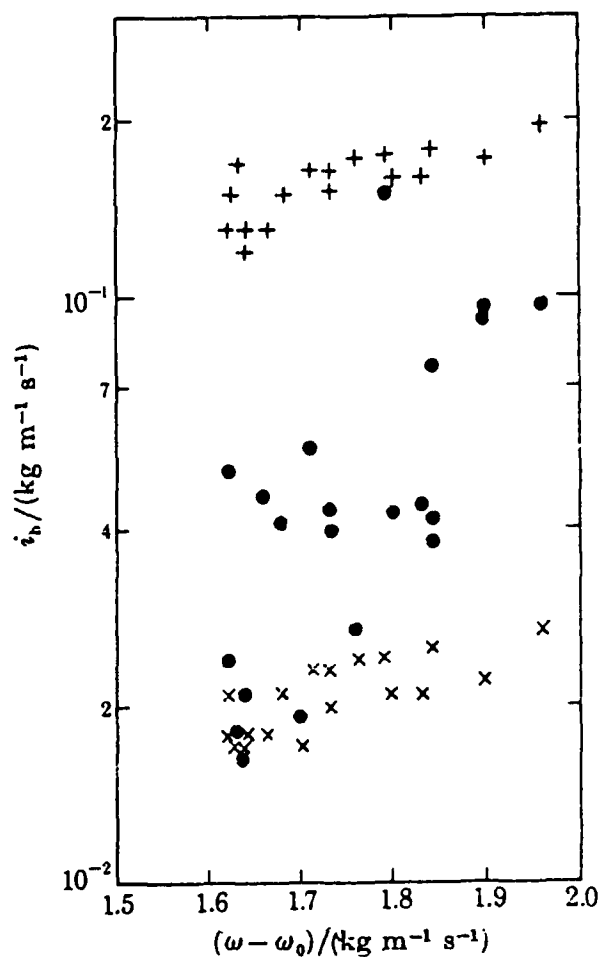
Tanana River. ●, measured  $i_b$ ; ×, computed  $i_b$  for  $D(\text{gravel})$  mode; +, computed  $i_b$  for  $D(\text{sand})$  mode. Measured  $i_b$  values fall at random between these limits.

Figure 4.8. Plot from Bagnold (1980, Fig. 4) showing measured and calculated bed-load transport vs excess stream power.

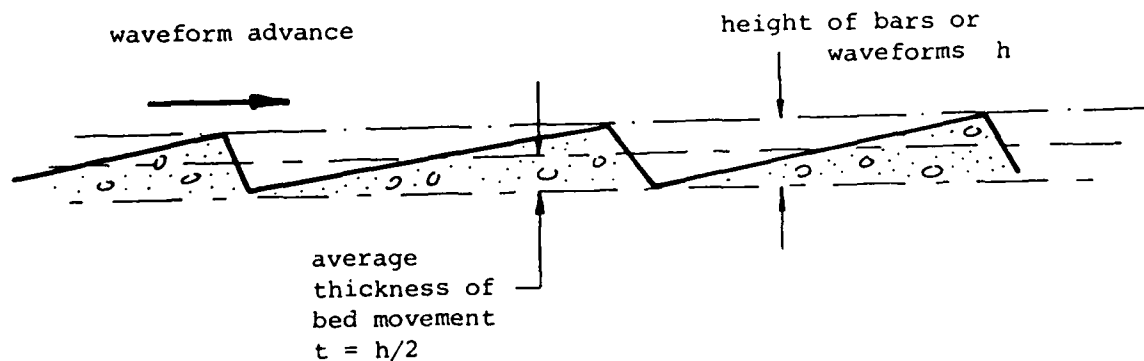
Figure 4.9. Diagram illustrating concept of estimating rate of bed-load travel.

Average thickness of bed movement (Figure 4.9) = 3 ft.  
 Equiv. thickness of sand (40% of bed material) = 1.2 ft.

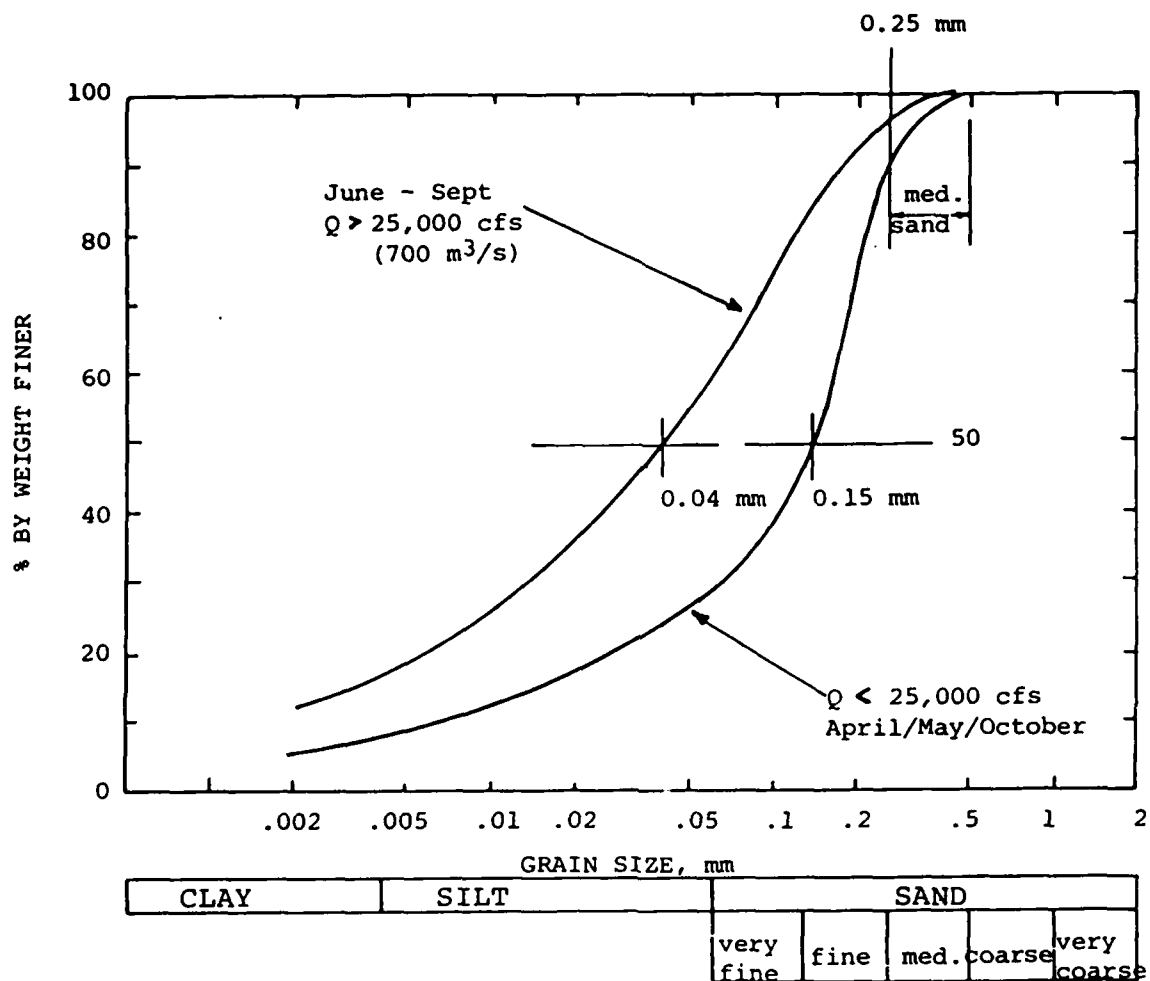
Figure 4.10. Mean grain-size distributions for suspended sediment at Fairbanks.

Approximate mean grain-size distributions at Fairbanks based on USGS data tables (Burrows et al., 1981) are shown in Figure 4.10 and key statistics are shown in Table 4.10. The data are shown grouped according to season, because it is evident from the original tables that the distribution is significantly coarser for flows of less than 25,000 cfs early and late in the season. Probable explanations are that ice and frost reduce the availability of finer sediments and that lower temperatures increase the suspendability of coarser sediments. Water temperatures range typically from 32°F in winter to 60°F in summer months.

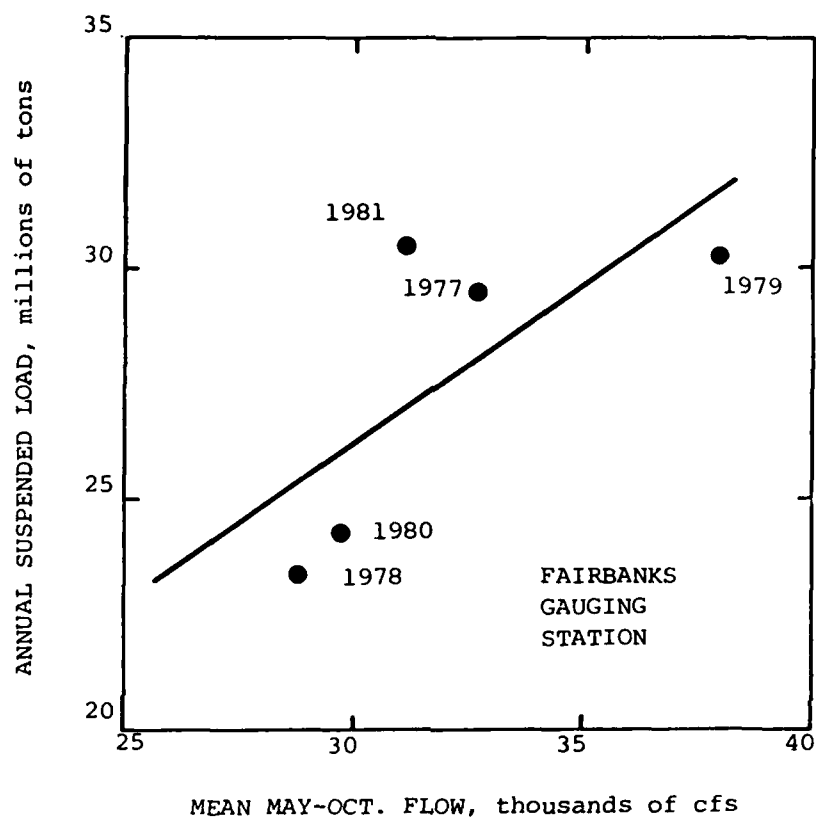
Figure 4.11. Annual suspended load vs mean May-October flows, 1977-81.

7. Annual suspended-load totals, which average about  $28 \times 10^6$  tons/year at Fairbanks, correlate reasonably with mean May-October flows. Approximately 15% of this total appears to consist of fine and medium sand sizes that are found in appreciable proportions in river bed material. If this suspended sand is considered to exchange with the channel boundaries, its average travel rate can be estimated as on the order of 25 miles per year.

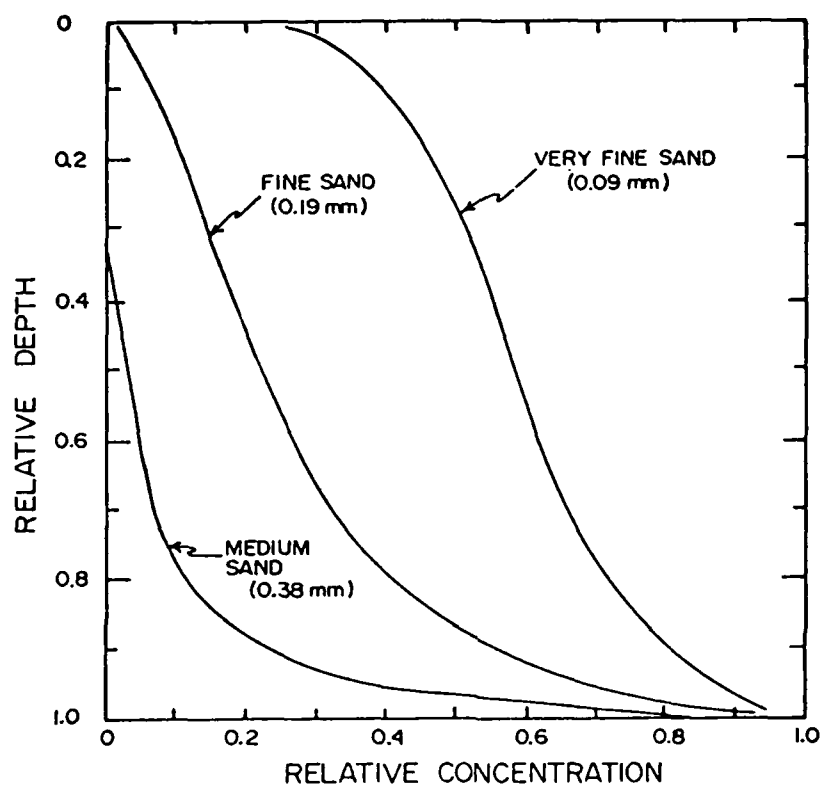
Figure 4.13. Estimated concentration-depth profiles for suspended sand sizes at Fairbanks gauge.

Relative sediment concentration profiles for various sediment sizes may be estimated for typical medium flow conditions at the Fairbanks gauge according to conventional equations (ASCE, 1975). This results in the curves shown in Figure 4.13 for medium, fine and very fine sand. These indicate that medium sand is heavily concentrated in the bottom 20% or so of the depth, fine sand is mostly in the lower 50%, and very fine sand is relatively uniformly distributed.

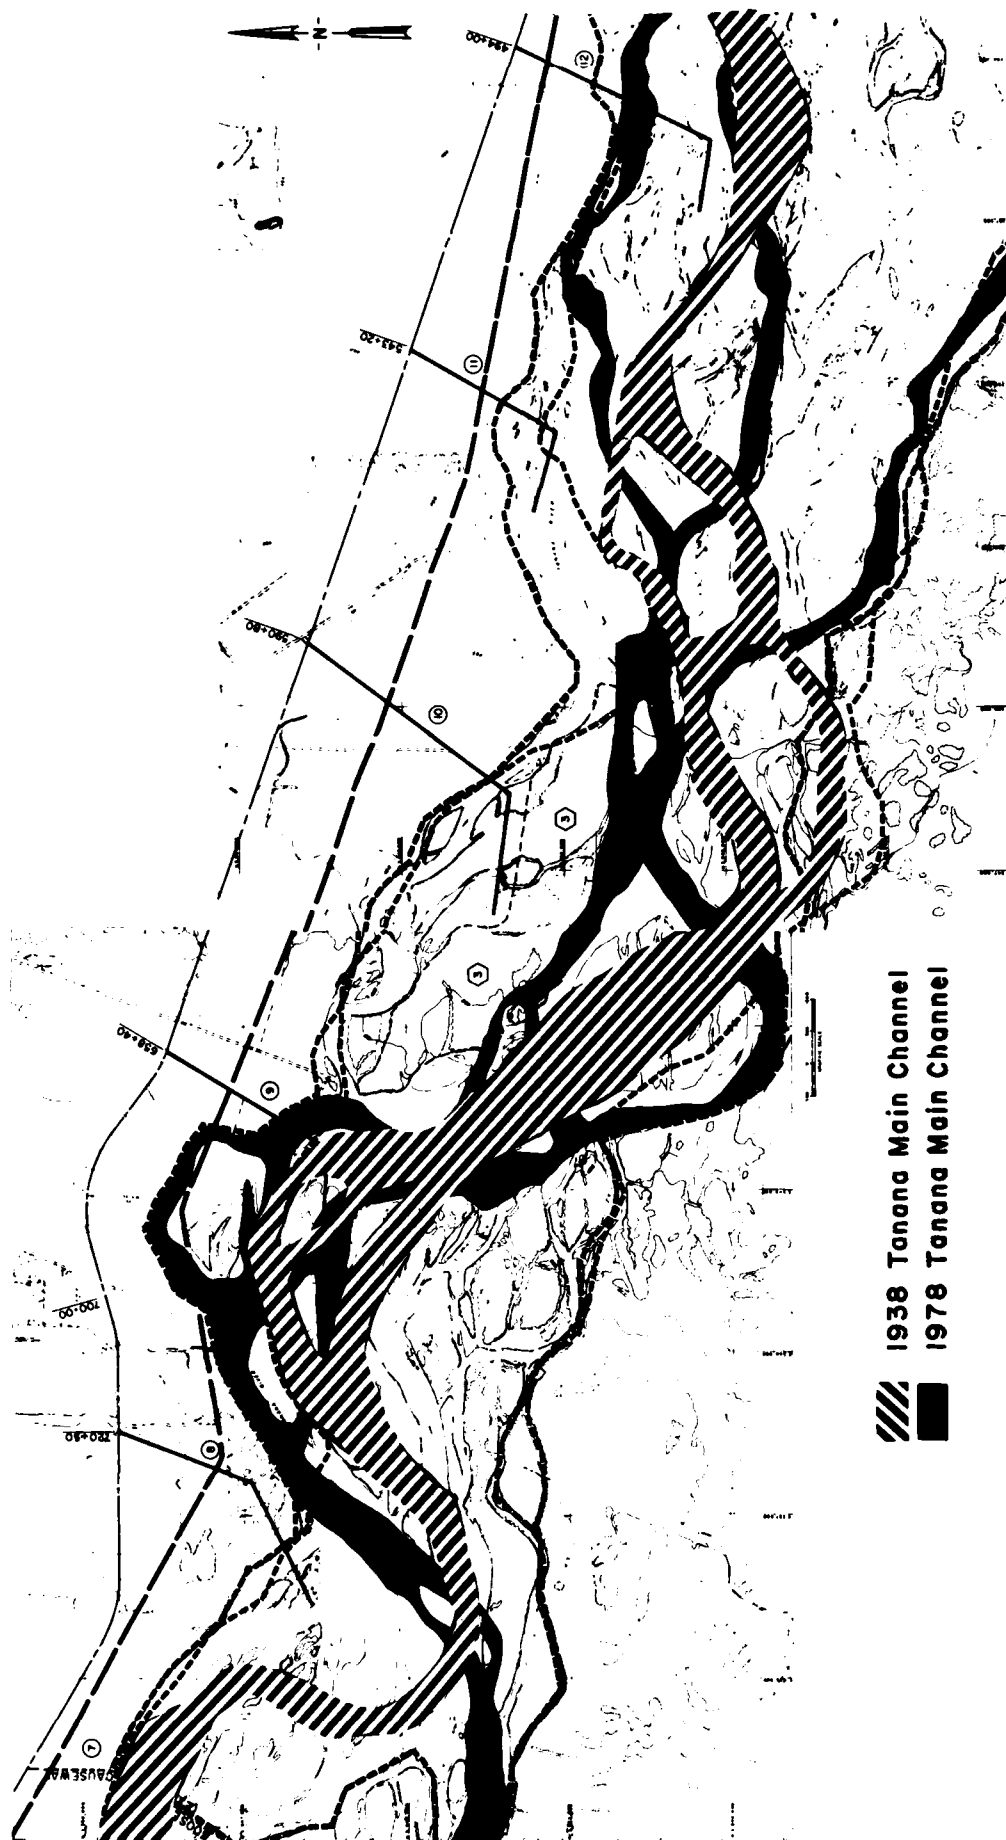
Figure 5.1. Apparent downstream migration of main channel loops upstream of Goose Island, 1938-1978.

Source Document (1) contains a set of colored maps, extending over about 22 miles from the Moose Creek floodway to downstream of the Chena mouth, which compare main channel and bank locations in 1938 and 1979. An extract in the vicinity of Meridian Island is shown in Figure 5.1. Although these maps can be criticized on the grounds of subjective interpretation of main channels and banks, they appear to demonstrate reasonably the gross changes that occurred over a 40-year period. Some key features may be noted as follows:

1,200 ft in a 40-year period, an average rate of about 30 ft per year (Figure 5.1).

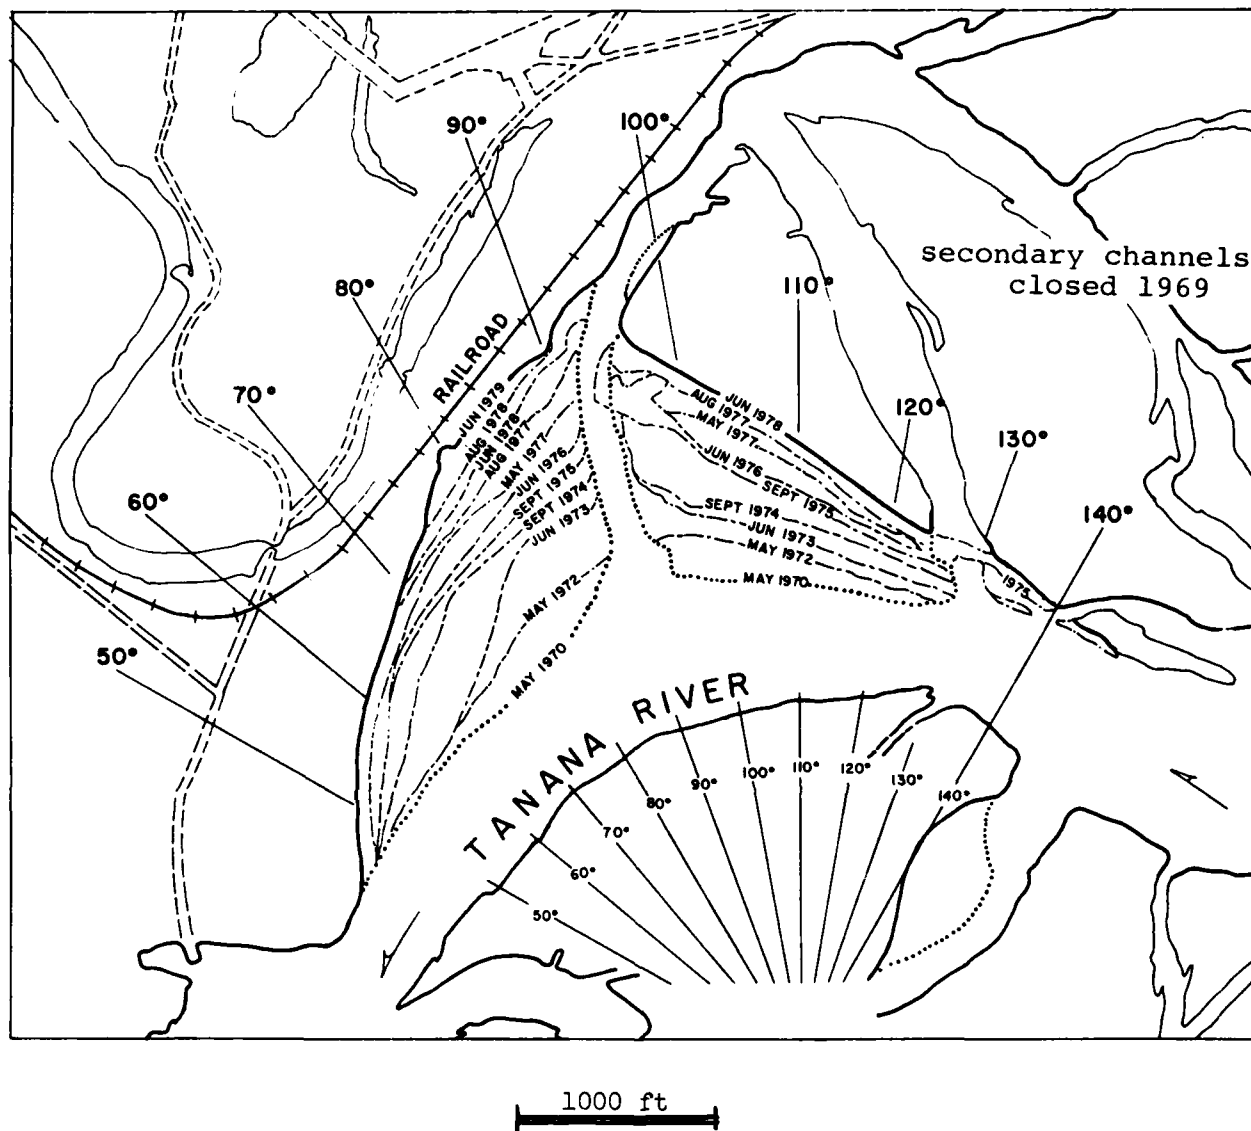
Figure 5.2. Bank recession, 1970-79, in Bend A, Phase III area. Based on D.M. 27 (Corps of Engineers, 1979).

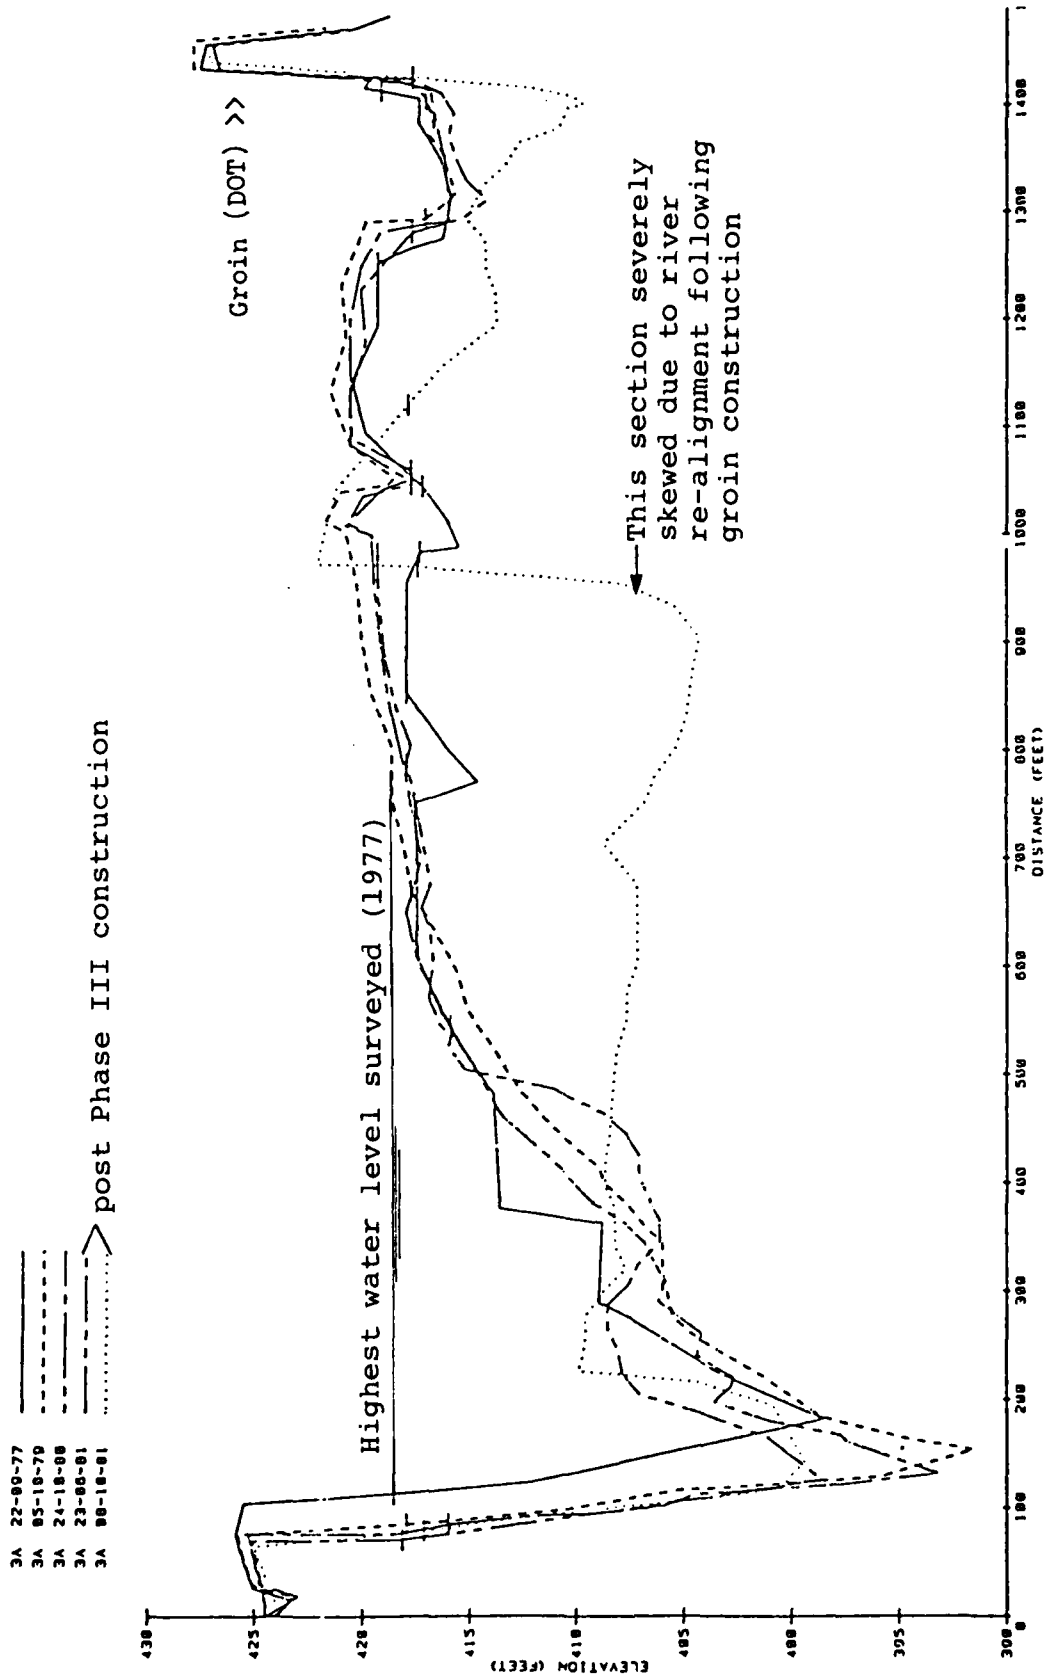
Figure 5.4. Typical bend cross section in Phase III area.

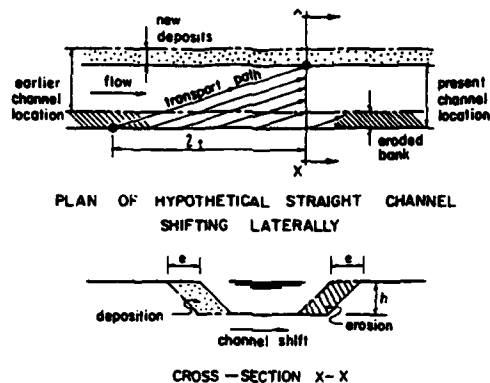
FIG. 1.—IDEALIZED LATERAL SHIFT PROCESS IN STRAIGHT CHANNEL IN STATE OF DYNAMIC EQUILIBRIUM ( $l_t$  = average travel distance of particles between erosion and deposition;  $e$  = width of erosion from right bank in specified time = width of accretion on left bank in same time; and  $h$  = height of eroding bank)

It can be seen from Fig. 1 that the volumetric rate of transport across any section X-X = volumetric rate of erosion from length  $l_t = l_t \times h \times (de/dt)$  in units of volume/time.

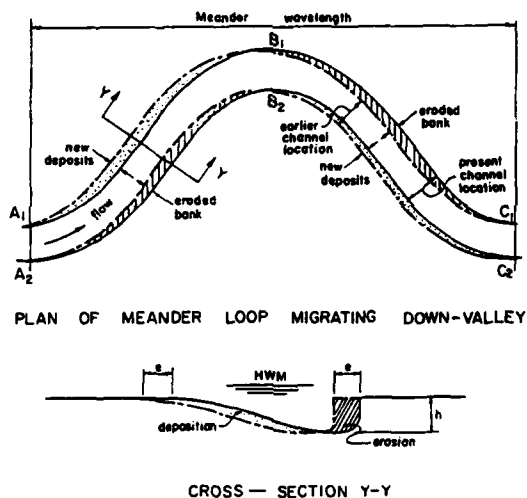
FIG. 2.—SIMPLIFIED MEANDER SWEEP PROCESS IN NATURAL RIVER [Assumptions: (1) Material deposited on bank  $A_1-B_1$  has come from upstream; (2) material eroded from bank  $A_2-B_2$  is deposited on  $B_2-C_2$ ; (3) material eroded from bank  $B_1-C_1$  is deposited downstream; and (4) average length of travel between erosion and deposition = length of channel in half meander wavelength] (Note—measured area of erosion  $A$  in one wavelength in specified time =  $\Sigma$  areas of erosion  $A_2-B_2$  and  $B_1-C_1$ )

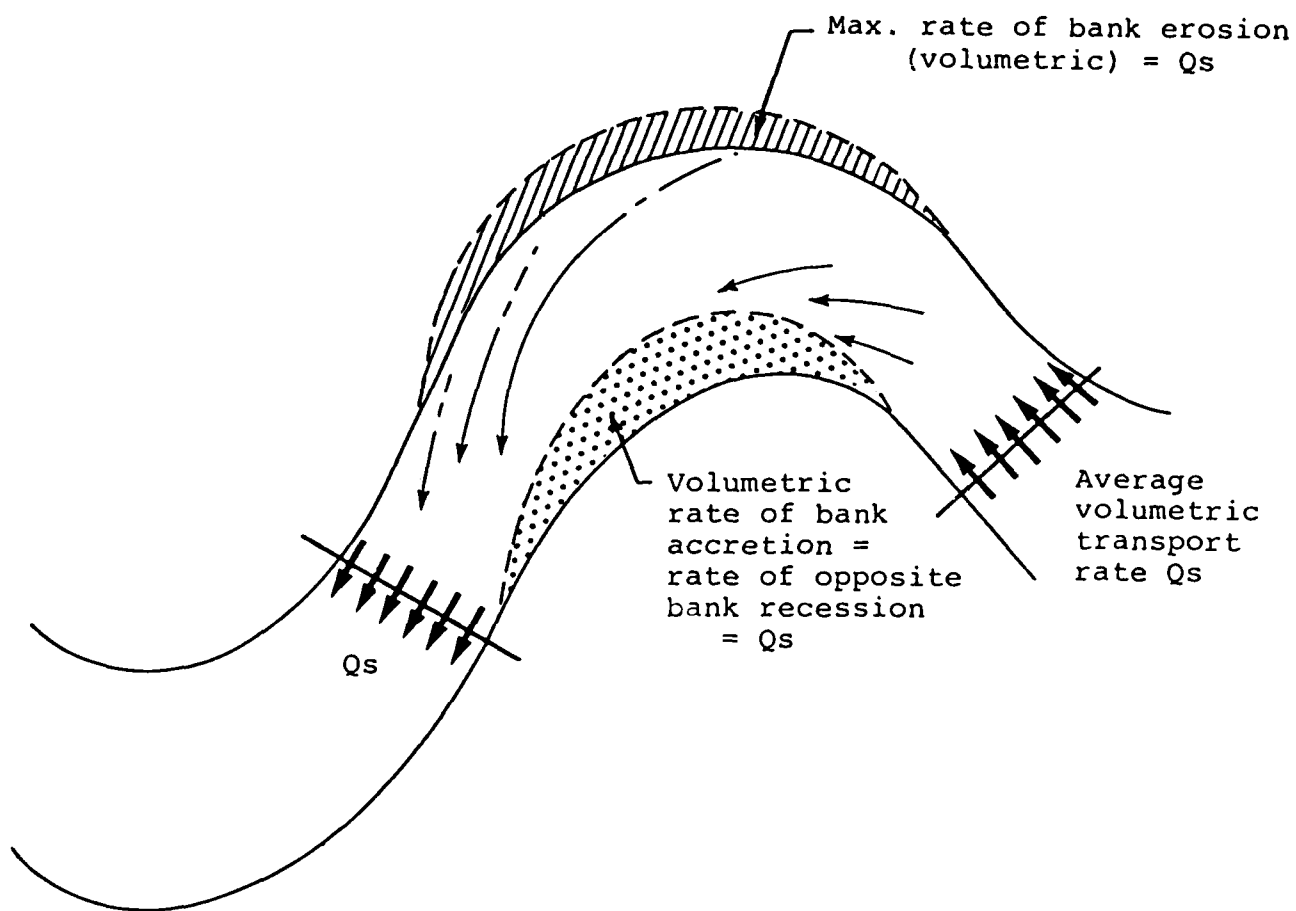
Figure 5.6. Bed-material exchange in channel bed. (Note: This represents an idealized process of complete exchange and is not necessarily exact for any particular site on the Tanana River.)

- (i) In an alluvial river in equilibrium, the average annual volume of bed-material erosion from a single channel loop cannot exceed the average annual volume of similar sediment transported across a section. When the two are equal, as illustrated in Figure 5.6, incoming sediment to the reach is deposited to form new floodplain on one side, while erosion removes old floodplain on the other, thereby providing bed-material transport to replace the loss of incoming sediment to deposition.

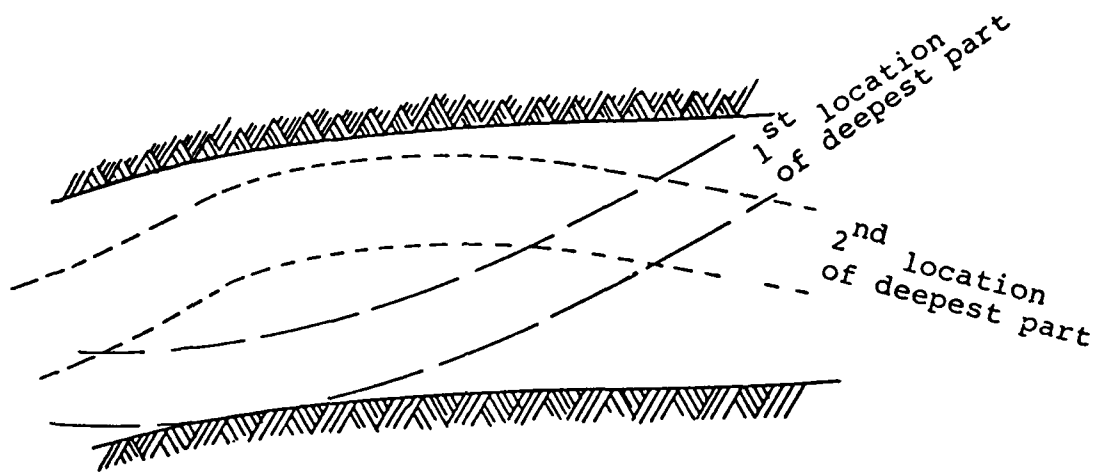
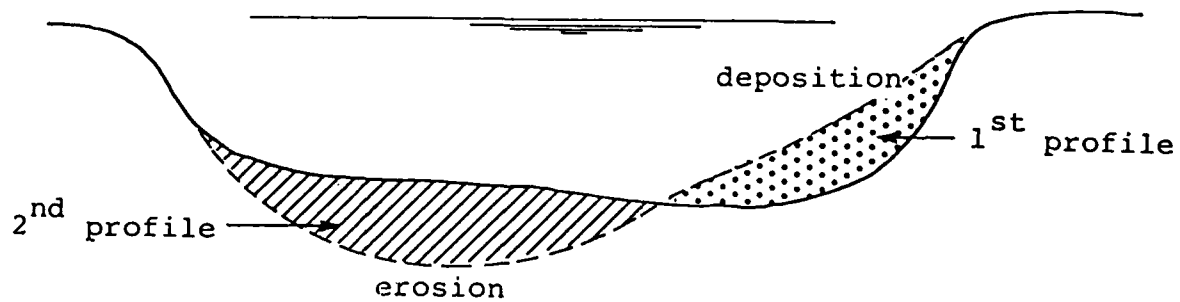
PLAN

Figure 5.7. Cross-sectional changes within fixed banks. Volume of sediment transported = average of erosion/deposition  $\times$  average distance travelled between erosion and deposition.

- (ii) The volumetric transport rate of bed material is equal to the rate of cross-sectional areal change multiplied by the average travel length of particles between erosion and deposition. This applies whether cross-sectional changes are taking place by (a) bank erosion and bank/bar deposition as illustrated in Figure 5.5 and 5.6; (b) thalweg and bar shifts within fixed banks as illustrated in Figure 5.7; or (c) a combination of both processes. It follows that in a given river, high rates of cross-sectional change are associated with short travel lengths (sharp curvature) and low rate with long travel lengths (flat curvature).

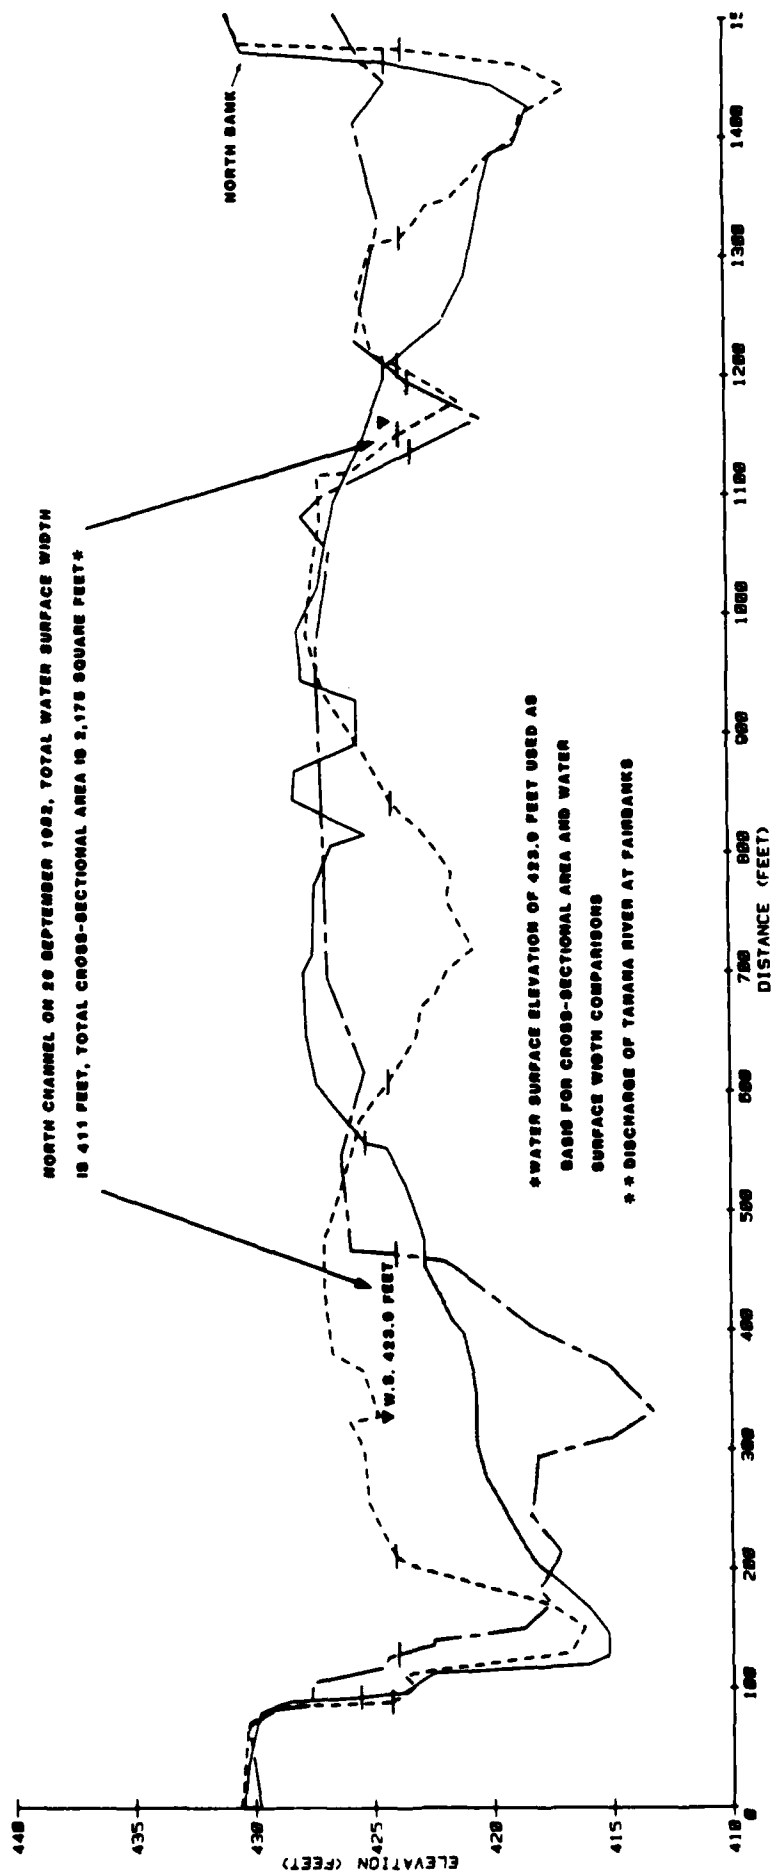
DATE	DISCHARGE **
7A 23-80-77	28,000 cfs
7A 88-18-78	18,400 cfs
7A 20-80-82	21,800 cfs (est.)

Figure 6.1. Comparison of cross-sectional changes in the north channel downstream of Goose Island, cross section 7A.

Figures 6.1 and 6.2 show cross-sectional changes which reflect the activities at Goose Island. Figure 6.1 shows cross section 7A in the north channel downstream of Goose Island, Figure 6.2 shows cross section 7C in the south channel, and Table 6.2 compares changes at 7A and 7C. A water surface elevation of 423.9 ft was used as a basis for comparison since it was an average of the water surface elevations measured during the surveys; the corresponding discharge was in the vicinity of 20,000 cfs. The distribution of flow area at this condition in 1977 was 56% in the north channel and 44% in the south channel. By 1982 these proportions had changed to 40% in the north channel and 60% in the south channel. Marked changes in cross-sectional shape also occurred within each of the main channels.

NOTE: A water surface elevation of 423.9 feet was used as a basis for area and water surface width comparisons (see Figures 6.1 and 6.2).

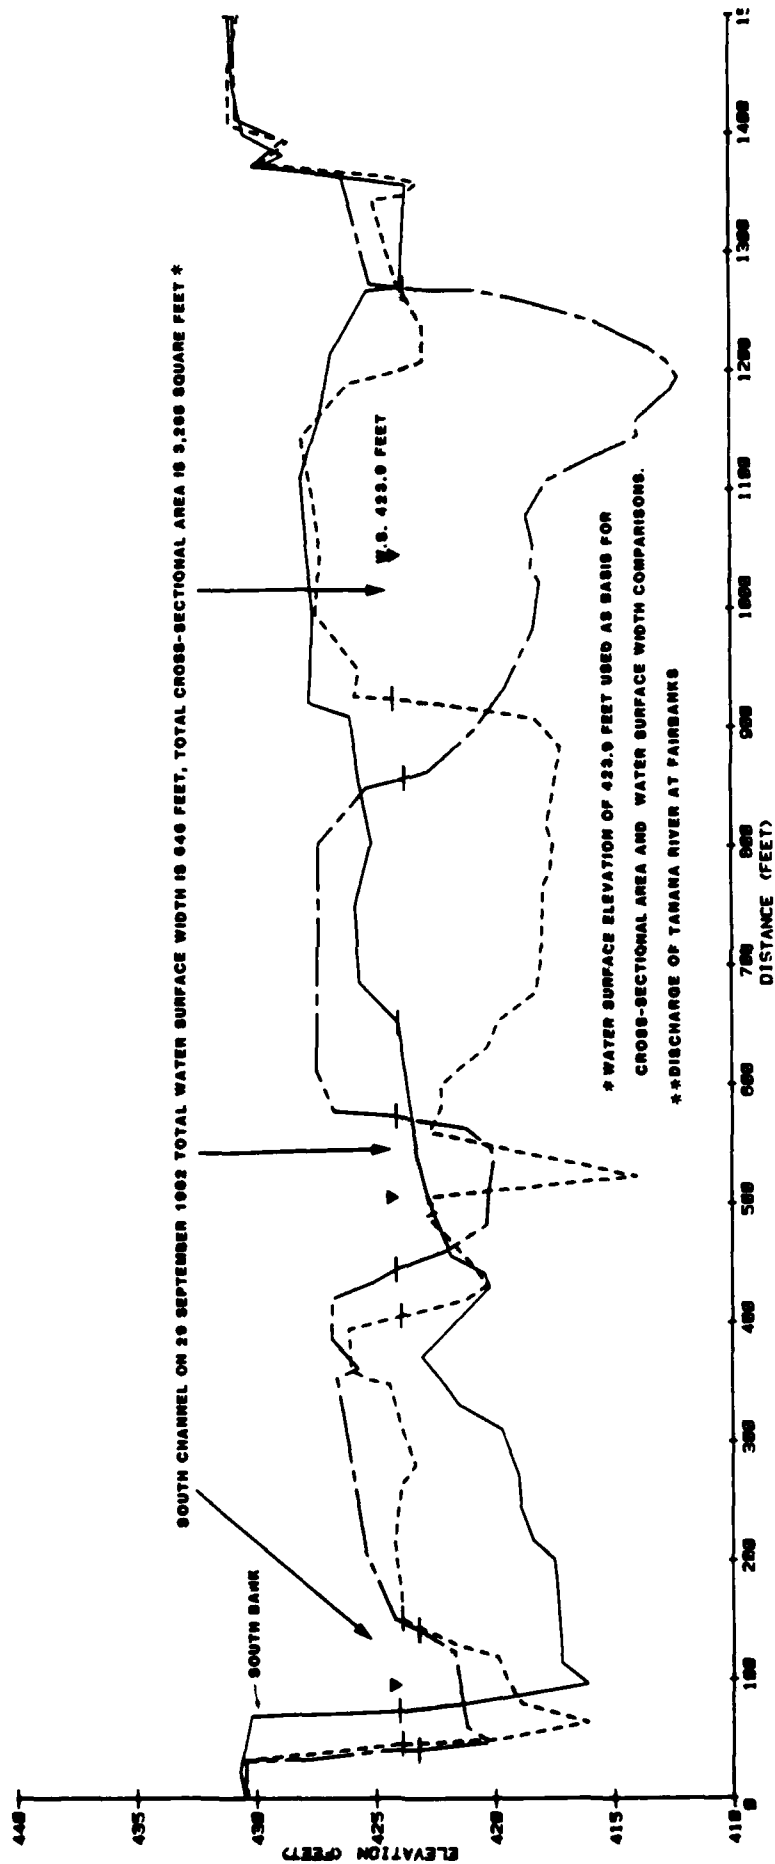
DATE	DISCHARGE **
7C 23-00-77	26,000 cfs
7C 07-10-78	19,400 cfs
7C 20-00-82	21,500 cfs (est.)

Figure 6.2. Comparison of cross-sectional changes in the south channel downstream of Goose Island, cross section 7C.

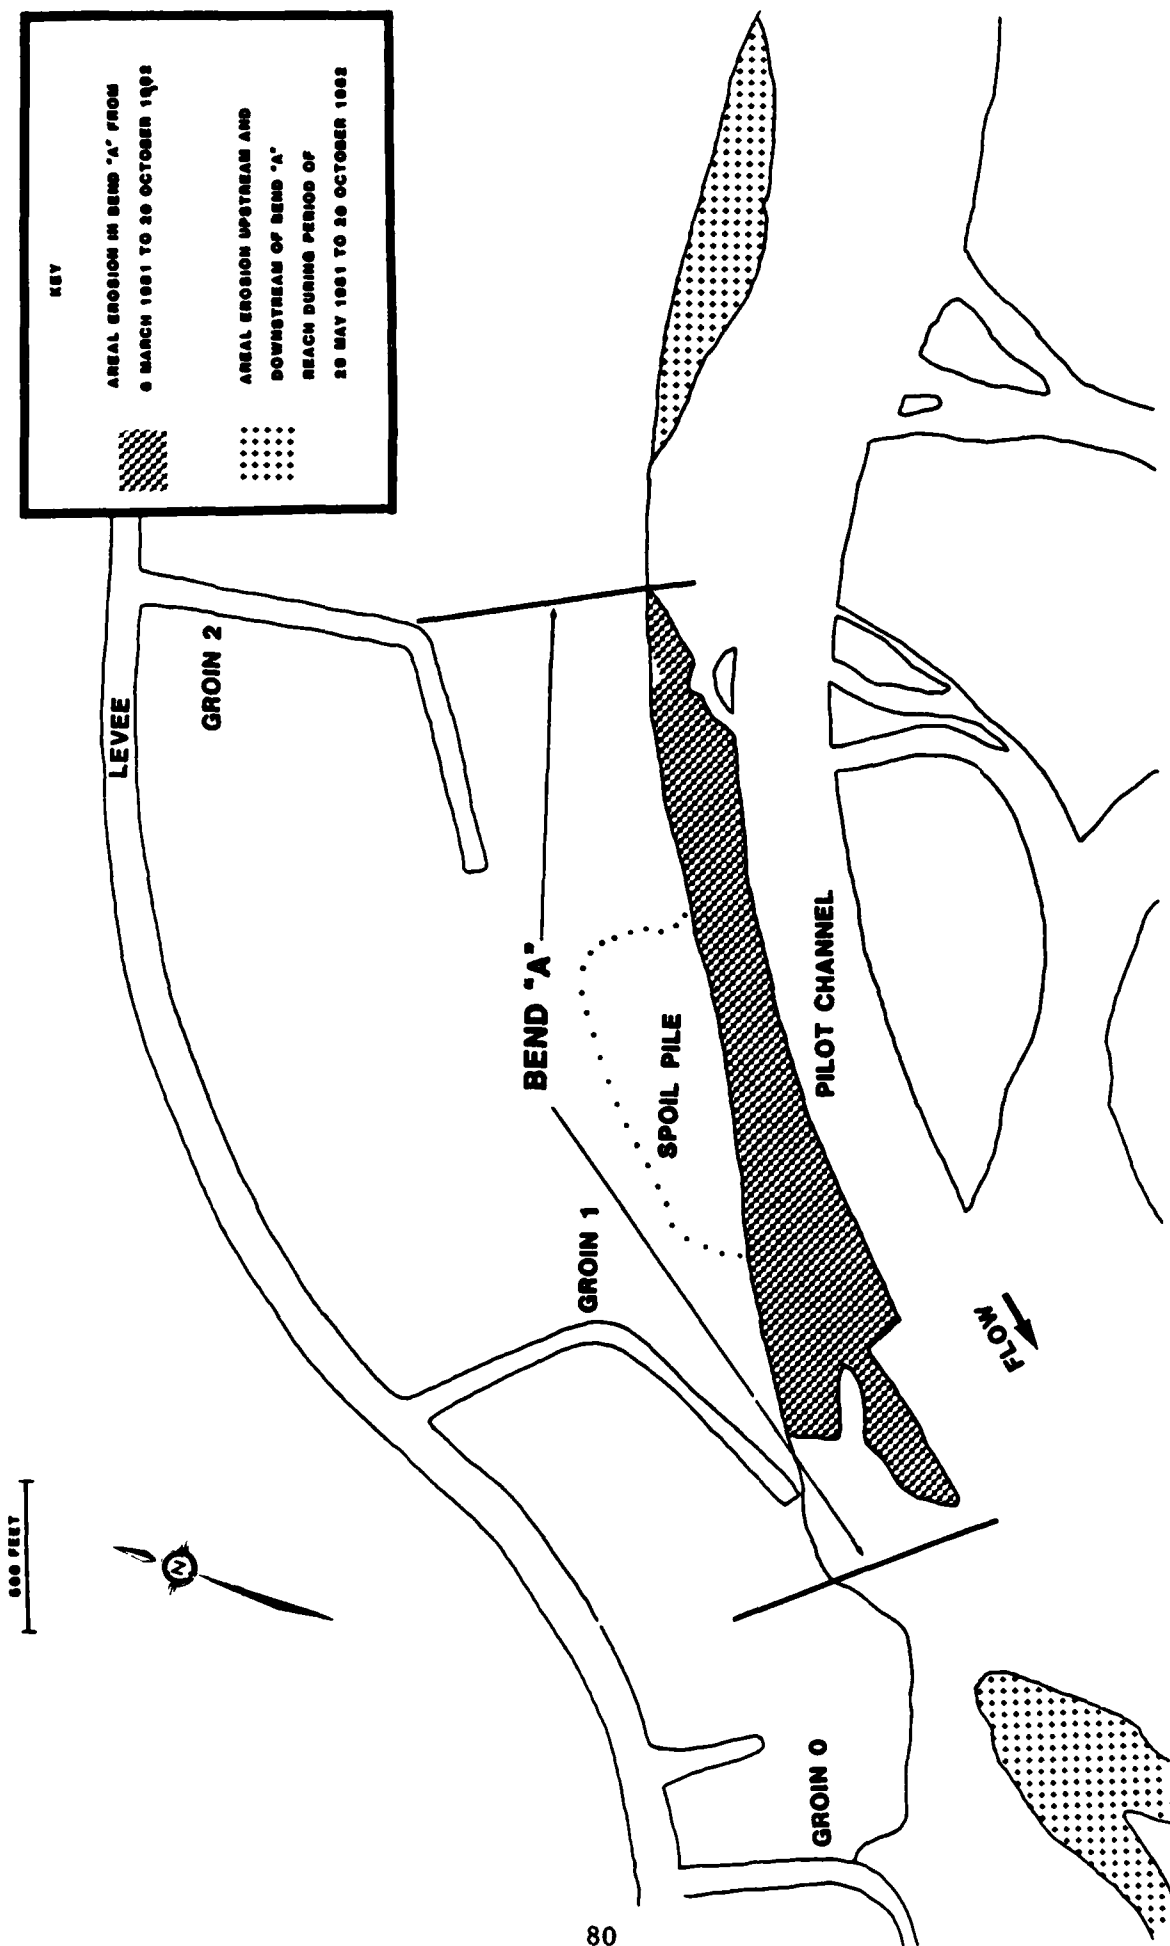
Figure 6.3. Bend A post-construction areal erosion.

The Phase III Construction completely cut off the large former meander in Bend A. Figure 6.3 shows the post-construction channel configuration and areal erosion of material between the north bank of the initial pilot channel and the faces of the groins. In order to take the differences of bank height and spoil pile volumes into account, Appendix A utilizes a volumetric analysis to compare amounts of material eroded from Bend A. The immediate post-construction volumetric erosion rate for the new Bend A (pilot channel) was 598,000 cubic yards per year between March and October 1981, 27% greater than the maximum pre-construction rate. Post-construction volumetric erosion rates for Bends B and C were 41,000 and 55,000 cubic yards per year respectively, or 34% and 10% less than pre-construction rates. Material eroding from Bend A appeared to be depositing in near the right bank of Bend B. Appendix A showed that a considerable amount of material remained to be eroded in Bend A before the channel would reach the face of the groins, and that the development of a bar at the mouth of the Chena River would have to be closely monitored. After reviewing information presented in Appendix A, it was decided that the remaining portion of the spoil pile to the north of the pilot channel would be removed from the active river channel during the winter of 1982-83.
